***SIGNAL RECOVERY* Model 3830**

Multiplexer Firmware Update Utility

Instruction Manual

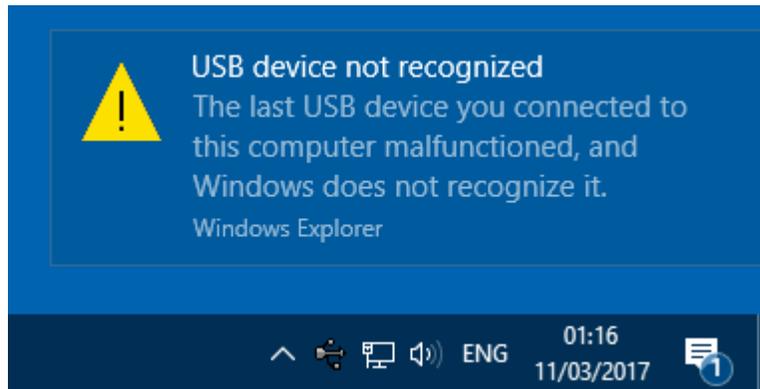
Figure 1, Error Message

The ***SIGNAL RECOVERY*** Model 3830 Multiplexer uses internal firmware stored in a programmable memory device. There is a bug in Version A of this firmware whereby when the unit is plugged into the controlling computer it returns an incorrect value in the Configuration Descriptor.

With versions of Windows up to and including Windows 7 this error did not cause a problem, but with versions since Windows 8 and where the computer has more recent USB hardware (especially if this complies with the USB 3.0 specification) then it can mean that the unit is not recognized, making it unusable with these machines.

If the SR3830 Multiplexer software is installed on these computers, then when the multiplexer is connected a message similar to that shown in figure 1 will be displayed.

The program SR3830Update.exe version 1.0 is designed to resolve the problem, by updating the firmware in the connected multiplexer to Version B. Once this has been done the unit will correctly operate on all versions of Windows from XP onwards.

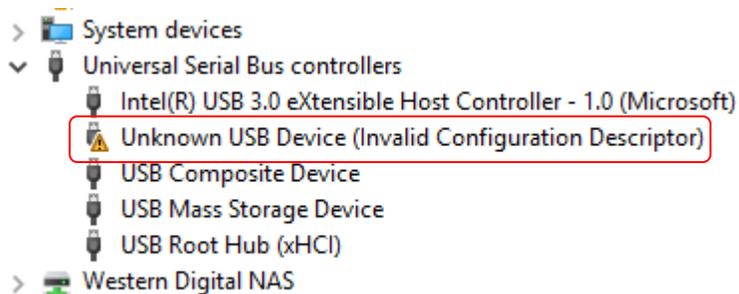
Figure 2, Device Manager (part listing), with Installation Error

If Device Manager is opened, then the multiplexer will be shown as an unknown USB device (figure 2).
